# Manhole Inspection Summary

Manhole # S35MM\_033MH

Insp Date: **3/6/07 12:05 PM**

**Location** Address: **100 22ND ST**

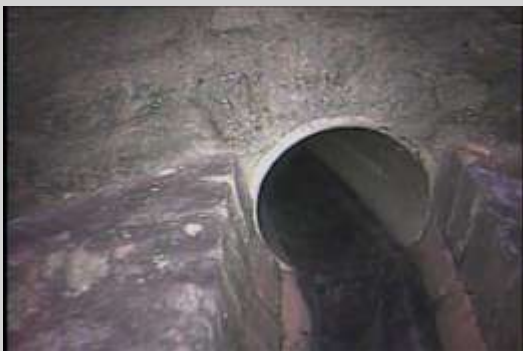
### 8 in. Circular Gravity Sewer Pipe In @ 6 O'Clock

Rod and Bar (Angled)

Pipe Material: **Clay** ☐ Pipe Lined

Invert Depth: **8.48** (ft.) Flow Characteristics: **Slow**

Deposits: ☒ None ☐ Mud ☐ Sludge ☐ Debris ☐ Grease

Infiltration: **None** Pipe Seal Cond: **Unknown**

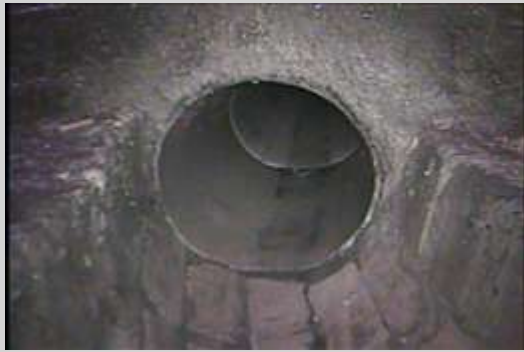
8 in. Circular Gravity Sewer

Rod and Bar (Angled)

Pipe Material: **Clay**

Infiltration: **None**
